## Phenomenology of soil erosion due to rocket exhaust on the Moon and the Mauna Kea lunar test site

Philip T. Metzger,<sup>1</sup> Jacob Smith,<sup>2</sup> and John E. Lane<sup>3</sup>

**Citation:** Metzger, P. T., J. Smith, and J. E. Lane (2011), Phenomenology of soil erosion due to rocket exhaust on the Moon and the Mauna Kea lunar test site, *J. Geophys. Res.*, 116, E06005, doi:10.1029/2010JE003745.

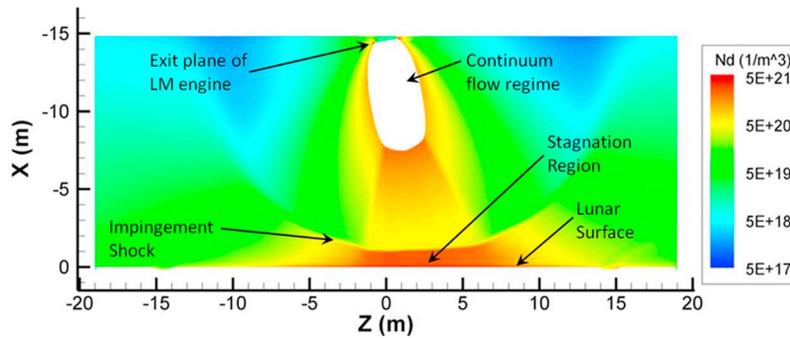
**Figure 1.** Density of the Lunar Module exhaust plume impinging on the lunar surface in numerical simulation. The “continuum flow” volume near the engine nozzle was simulated by a Navier-Stokes solver while the remaining, rarefied volume was by the Direct Simulation Monte Carlo method. Courtesy of F. Lumpkin, NASA Johnson Space Center.

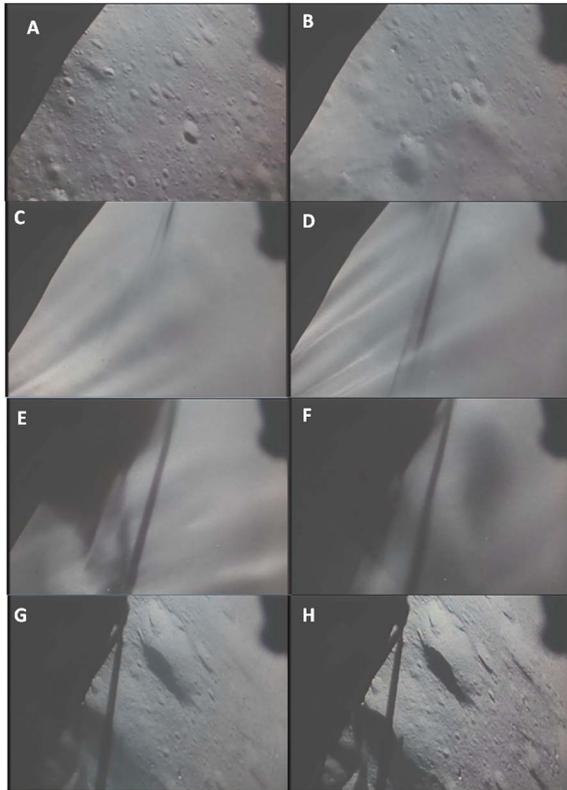
**Figure 2.** Data Acquisition Camera views for Apollo 15, showing the stages of plume/soil interaction: (a) before incipient erosion, (b) smooth flow stage, (c and d) streaking stage, showing increasing structure in the streaks, (e and f) terrain modification stage, showing opaque masses of blowing soil, (g) clearing stage, and (h) after clearing has completed, showing increased contrast and resolution of shadow edges.

[10] Despite the differences between the six landings, their videos demonstrate a core of similar phenomena and can be divided into four stages, which are shown in Figure 2.

[11] First is the smooth flow stage, in which a reduction of contrast or haziness grew within the image of the lunar surface. This is the result of light scattered from a generally homogeneous sheet of dust moving radially away from the impingement point, which was below the lower left corner of the video image. The LM altitude for the onset of this haziness averaged around 30–40 m and indicates the conditions of incipient erosion. Analysis of shadows on the dust sheet [Immer *et al.*, 2008] and simulations of particle trajectories in a simulated lunar rocket exhaust plume [Lane *et al.*, 2008, 2010] agree that the dust sheet was angularly thin in the vertical direction and moved away from the impingement point at an angle of about 1 to 3 degrees above the local terrain.

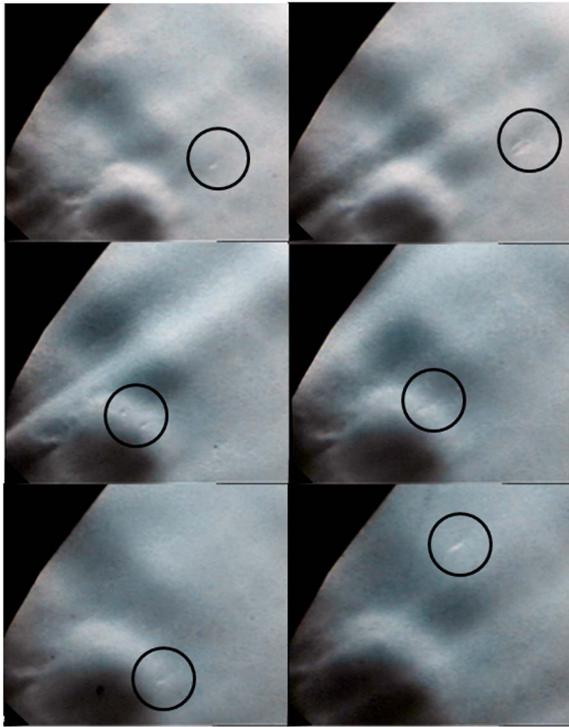
**Figure 3.** Eight dust tails during the Apollo 14 landing. (Two of the circles contain two dust tails, each.)

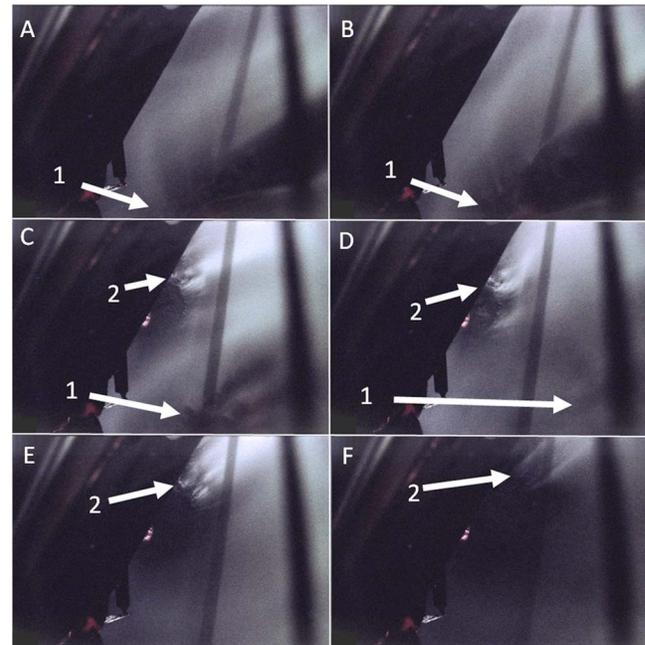
**Figure 4.** In time sequence from Figure 4a to 4f: two localized “bursts” (numbered) seen in Apollo 12 landing, with dust streaks emanating at a higher velocity from the denser bursts.

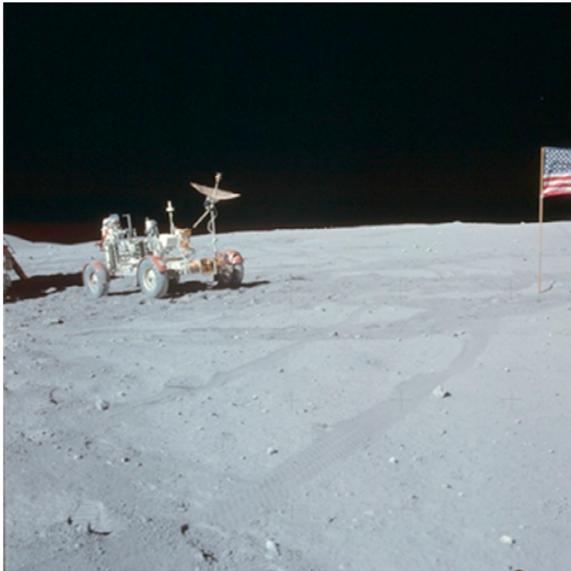
**Figure 5.** Apollo 16 LRV and flag (NASA photograph A16-107-17438HR). Footsteps and rover tracks darkened the appearance of the soil by mechanical disturbance.

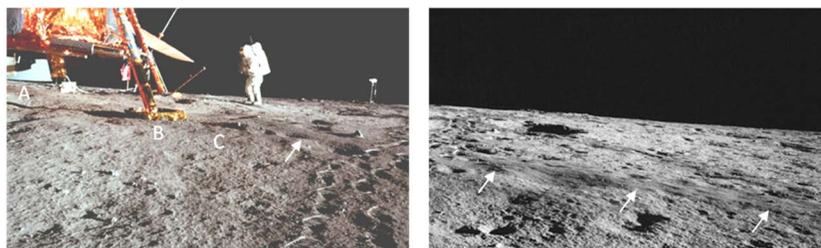
**Figure 6.** Two nearly contiguous photographs showing a dark streak (marked by arrows) oriented radially away from the Apollo 12 LM engine nozzle (A), footpad (B), and contact probe (C). (Details of NASA photographs AS12-46-6779HR and AS12-46-6781HR, contrast enhanced.)

rocket exhaust plume expanding into lunar vacuum. It is along a ray that extends from the engine nozzle through the footpad and soil contact probe. We suggest that it is depositional material and that it stands out from the surrounding terrain because deposition is rare this close to the LM. Plume ejecta were usually lifted by the aerodynamic forces and sent great distances on the order of kilometers to thousands of kilometers [Lane *et al.*, 2008, 2010]. This ray of material was most likely ejected in the terrain modification stage when the soil contact probe broke up the surface. On Apollo 12 the engine was shut down at the first indication of contact from these probes. Hence, the material was part of a bulk release, which would accelerate more slowly than finely dispersed particulates, and the aerodynamic forces were diminishing just as it was released. After nearby deposition along the narrow ray, the material was never subjected to subsequent sweeping of the plume and hence was left with a different texture and photometric function than the surrounding, brighter, plume-swept soil.

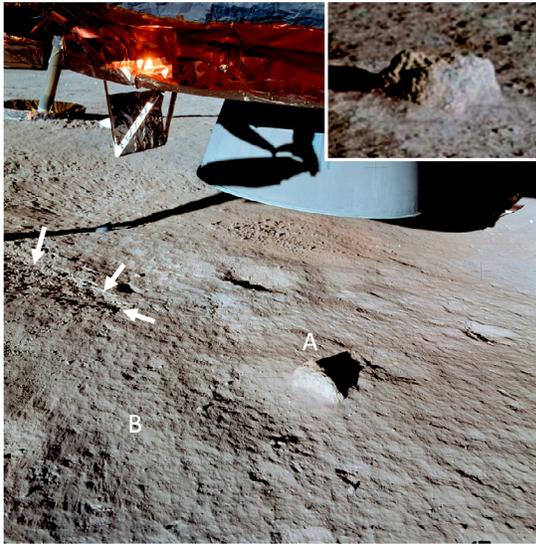
**Figure 7.** Apollo 14 surface (NASA photograph AS14-66-9261HR). Arrows indicate a well-defined contact where the upper soil layer was removed to a consistent depth. Rock A was found beneath nozzle after landing. Surface B has a hummocky texture after being worked by the plume. Inset shows the same rock A from another perspective showing that it is still embedded in the ground. (Detail from NASA photograph AS14-66-9266HR.)

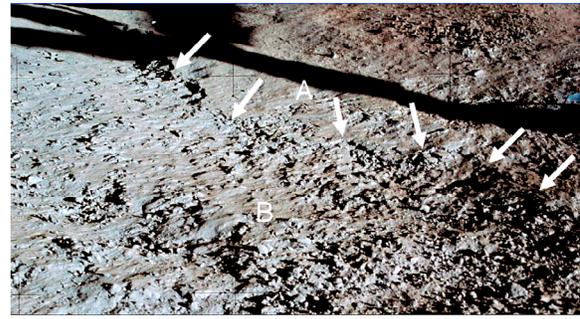
**Figure 8.** Apollo 14 surface showing contact between soil layers where upper layer A was stripped away exposing layer B, on which gravel and/or clumps with erosional remnants lie. (Detail from NASA photograph AS14-66-9267HR, contrast enhanced.)

layer where it had not been completely removed. The thickness of the upper layer all along the length of the contact is consistently about 1 cm, which we estimate using the engine nozzle diameter as the reference. Figure 8 shows the Apollo 14 soil layering from another perspective. Discrete contacts between upper and sub layers were present in the photography for Apollo 11 (shown in Figure 9), 14, and 15. Some well-defined shadows on the soil in Apollo 12 might also represent soil layer contacts. This may have been a source of the clods reported by Bean. In Apollo 16 and 17 there were fewer pictures taken beneath the LM. Thus, the removal of soil in discrete layers appears to have occurred generally, not just in isolated cases.

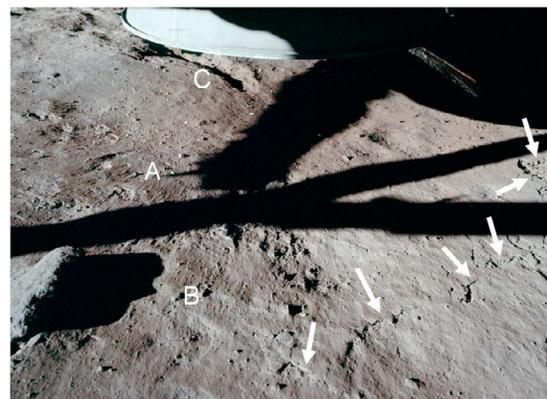
**Figure 9.** Apollo 11 surface. Arrows show the contact between the upper soil layer and the sublayer. Area A has numerous radial erosional remnants, each headed by gravel. Area B has a set of short longitudinal features in the form of downward steps from the impingement point. Trench C was caused by the soil contact probe during landing. The engine nozzle is visible at the top. (Detail from NASA photograph AS11-40-5921HR.)

[18] It is remarkable that this erosion by discrete layers was never identified in the Apollo imagery until now. The most obvious example provided by Apollo 11 (Figure 9) is easily misinterpreted as fissures in a flat surface, possibly

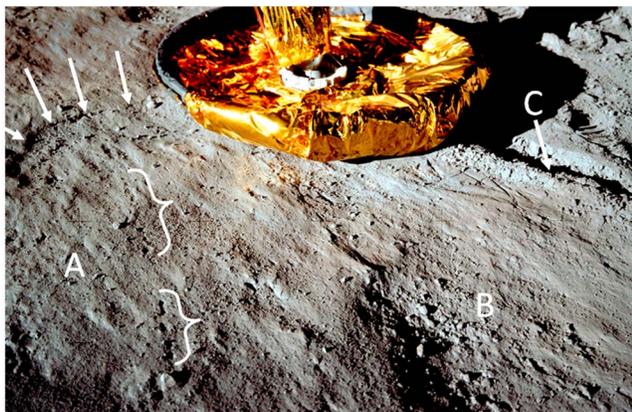
**Figure 10.** Apollo 11 surface showing A, unheaded erosional remnants, B, swath of soil compressed and disturbed by footpad, and C, trench dug by contact probe. Tips of four arrows touch a contact between an upper, partially eroded soil layer and sublayer. The two braces identify a series of skip marks ending at a rock that might have caused them. (Detail from NASA photograph AS11-40-5918HR, contrast enhanced.)

[20] Last, several other identifiable but less common features are noted. These include small holes, from which gravel or rocks may have been removed by the plume. Other holes in linear arrangement as in Figure 10 could be skip marks, where a bouncing rock repeatedly struck the surface. These are similar to the series of pits seen on Mars near Viking 1, which were interpreted by Moore *et al.* [1987, see Figure 22B] to be skip marks from an ejected rock. There are also some short longitudinal features or “stair steps” shown marked as B in Figure 9. Judging by their relationship to the eroded contact between soil layers, these are probably contacts of natural soil strata that have been very imperfectly removed. Other than the dark streak shown Figure 6, discussed above, there are no identifiable depositional features, only erosional ones. This is understandable considering the low gravity and the high gas velocity of the plume that resulted in saltation lengths on the order of kilometers to thousands of kilometers [Metzger *et al.*, 2010a].

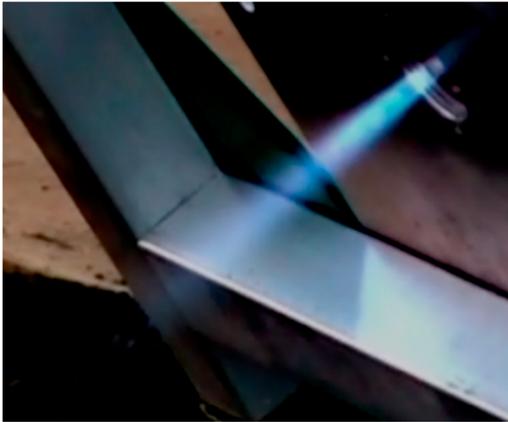
**Figure 11.** Supersonic jet (plume) from LOX/CH<sub>4</sub> thruster showing several faint Mach disks (firing at 2500 m altitude on Mauna Kea).

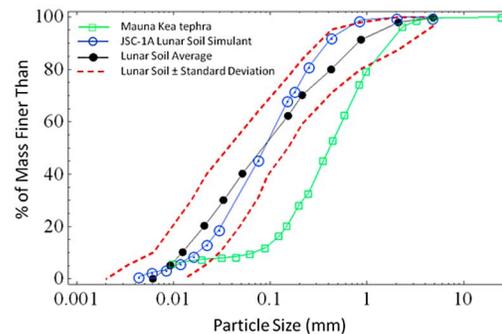
**Figure 12.** Particle size distribution of test site tephra compared to lunar soil and JSC-1A lunar soil simulant. Lunar and JSC-1A data courtesy of Xiangwu Zeng, Case Western Reserve University [Zeng *et al.*, 2010].

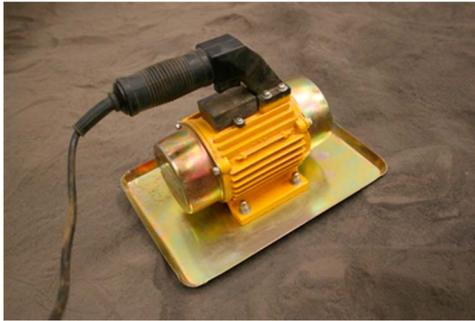
**Figure 13.** Vibrational hand compactor used to densify the tephra.

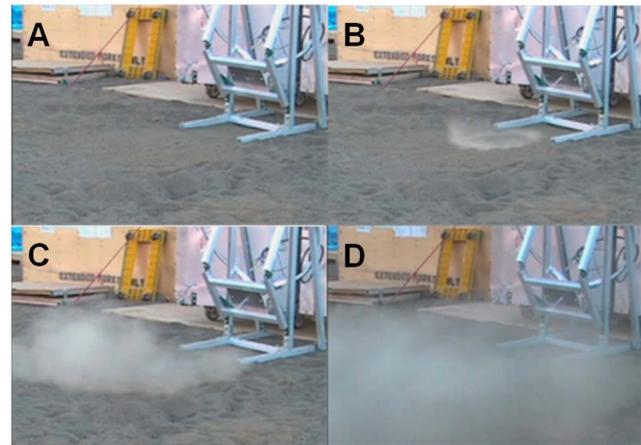
**Figure 14.** Typical thruster firing. (a) Before ignition. (b) Splash stage. (c) Advection stage. (d) Clearing stage.

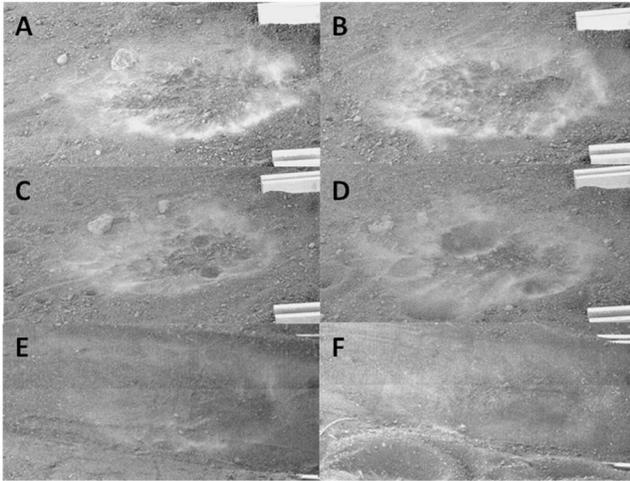
**Figure 15.** Splash stage: dust ring raised around impingement point at thruster ignition. (a–d) Test cases 1 through 4 using unmodified soil. (e) Test case 5 using vibrationally compacted soil. (f) Test case 6 using vibrationally compacted and tamped soil.

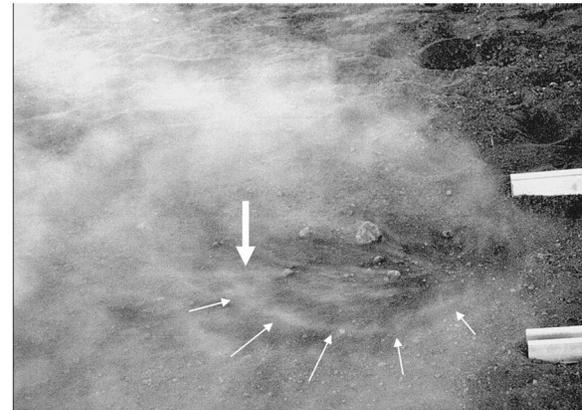
**Figure 16.** Advection stage. Wide arrow indicates a typical radial dust streak. Thin arrows indicate a typical annular structure in the blowing dust.

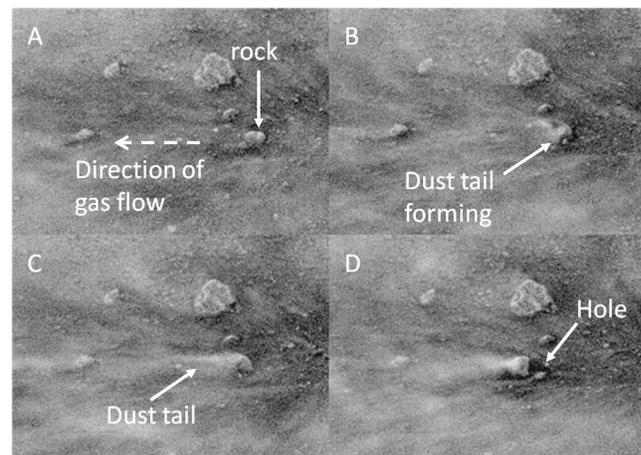
**Figure 17.** Exhumation of a rock showing the formation of a dust tail just before the rock moves.

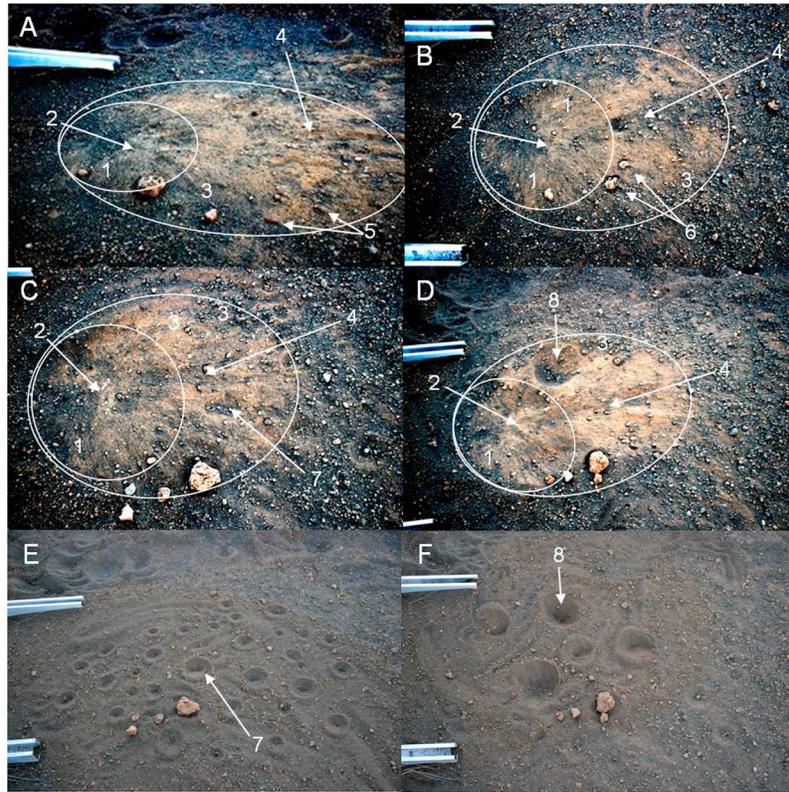
**Figure 18.** Residual brightening of eroded surface (contrast enhanced). Direction of gas flow was left to right. (a–d) Test cases 1 through 4, respectively (contrast enhanced); (e and f) test cases 3 and 4 prior to thruster firing, for comparison. Features are (1) circular crater, (2) central bulge, (3) shallow pan, (4) axial flute, (5) examples of erosional remnants, (6) examples of flutes trailing obstacle scour, (7) example of partially survived crater, and (8) crater that survived intact except for its raised rim.

[29] As shown in Figure 18, the terrain at and around the impingement point was found to have been left visibly brighter with a yellowish appearance relative to the darker gray of the bulk tephra. This might be analogous to the brightening around the Apollo landing sites. The gravel, which had been transported as bed load, was concentrated in a wide band just beyond the brightened zone. The brightened zone was identical to the region in which erosion occurred, as indicated by the lowering of the surface. This zone was roughly elliptical with a downrange length of about 60 cm and a width of about 30 cm. The upstream end that included the impingement point was deeper, consisting of a roughly circular crater that was about 3 cm deep. The remainder of the ellipse (downstream from the impingement point) was a flat, shallower pan of about 6 mm depth. An “axial” flute extended along the direction of the jet through

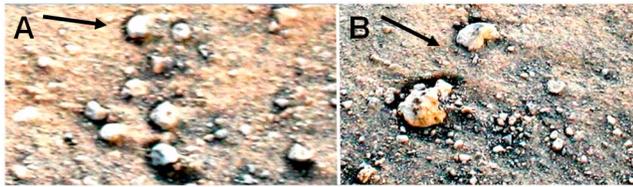
**Figure 19.** Variations of brightening on short length scales is negatively correlated to erosion (contrast enhanced). Arrows show approximate direction of gas flow. (a) Erosional remnants behind particles of gravel. (b) Two examples of obstacle scour.

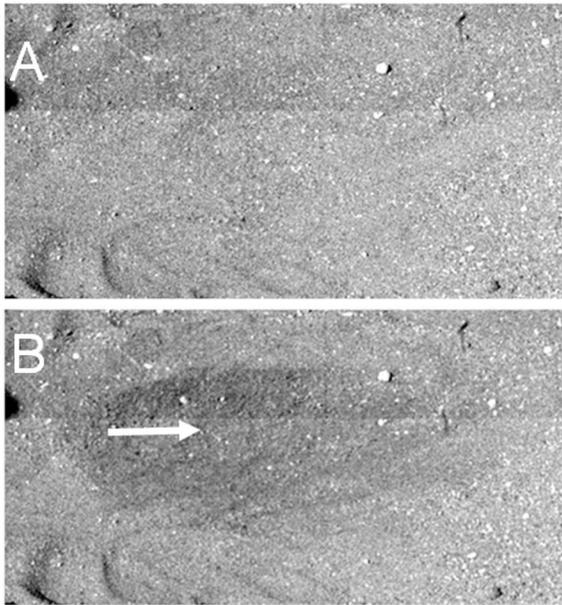
**Figure 20.** Case 7 (a) before ignition and (b) during the splash stage. The dust ring is absent. Arrow shows the direction of gas flow from the impingement point (reverse perspective compared to Figures 15).

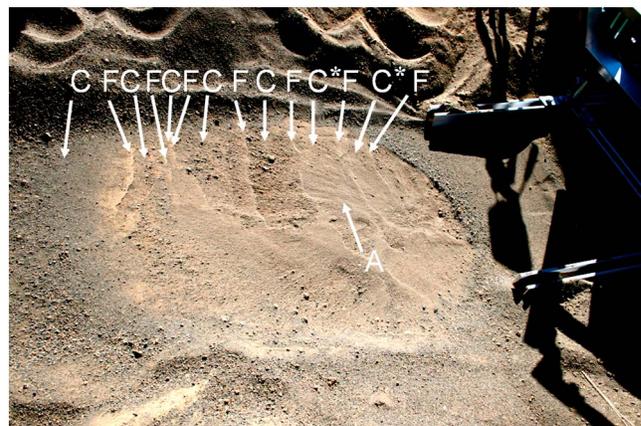
**Figure 21.** Lamination in soil exposed during case 7 (contrast enhanced). F, fine layers; C, coarse layers; C\*, presumed location of coarse layers completely removed by plume; A, unheaded erosional remnants. Note brightness in eroded region, in this case due to removal of coarse particles.

[36] The moisture content was serendipitous as it caused the erosion in both cases 7 and 8 to occur in thin layers, or laminae, as shown in Figure 21. The thickness of these laminae was on the order of 1 mm. Examining Figure 21 carefully, it can be seen that they alternate between fine and coarse particles. Coarse particles are less cohesive and more easily removed by the plume than are the fines in the presence of remnant moisture. Close to the impingement point it appeared that the intervening coarse layers were completely removed. Further away from the impingement

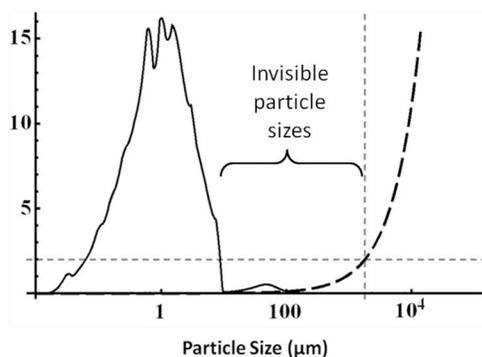
**Figure 22.** Visibility of different particle sizes in recorded videos. Solid curve indicates surface area of blowing lunar soil per micron particle size ( $\text{cm}^2/\mu\text{m}$ ). (This is scaled for an arbitrary quantity of soil.) A similar analysis has not been performed for test site tephra, but the overall mass fraction below  $10 \mu\text{m}$  is comparable to lunar soil, so the visibility of tephra dust is expected to be similar. Heavy dashed curve indicates camera pixels per individual particle at the test site. Light dashed lines indicate guides to the eye at  $1800 \mu\text{m}$  and 2 pixels.

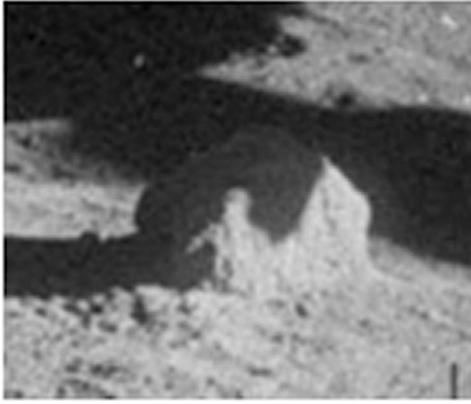
**Figure 23.** Rock under Apollo 12 engine bell. (Detail from NASA photograph AS12-48-7034HR.)
